## Safety In Vehicle Cabs

An incident recently occurred when an employee was fortunate not to be seriously injured. The employee was driving a loading shovel when a can of spray marker paint 'exploded' in the cab. The spray paint can had been kept loose behind the seat.

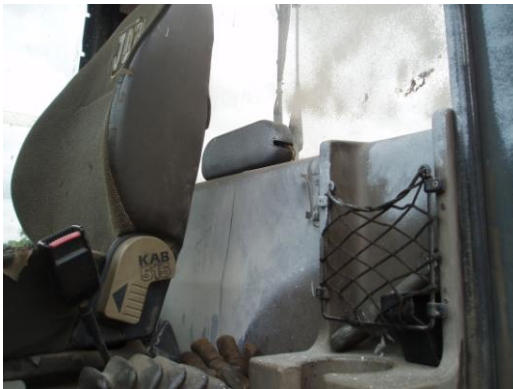
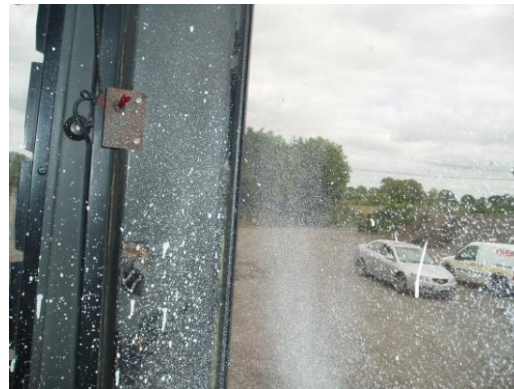
The exact cause of this incident cannot be determined, but there are a number of possibilities:

- The can rolled under the seat and was punctured as the loading shovel travelled across rough ground causing the seat to bounce up and down.
- The pressurised can was overheated as it was exposed to the sun magnified through the loading shovel window.
- The can was damaged by being trapped in the door.

**When driving or operating any vehicle or plant item the following safe working procedures should be applied at all times:**

- **ALL vehicle and plant cab areas should be inspected daily, before starting work, to ensure the area provides a safe working environment.**
- **Ensure that ALL pressurised containers are SECURELY STORED in vehicles at all times.**
- **NEVER leave pressurised containers or any other loose articles behind vehicle seats or in vehicle footwells where they can become damaged or create other hazards.**
- **NEVER leave pressurised containers where they can be exposed to direct sunlight or any other heat source.**
- **Keep all vehicle cab areas clean and tidy at all times!**
